SPECIAL REPORT E-107
June 1977

RADIO FREQUENCY SHIELDING TESTS OF SYSTEM TECHNOLOGY
TEST FACILITY AT MECK ISLAND, MARSHALL ISLANDS

20. ABSTRACT (Continue on reverse side if necessary and identify by block number) This report presents the results of tests and inspections performed to verify the shielding integrity of the newly constructed Systems Technology Test Facility (STTF) on Meck Island, Kwajalein Atoll, Marshall Islands. Recommendations for improvement of the structure's effectiveness, including suggested maintenance techniques and recommendations for additional testing, are presented. The report also evaluates the radio

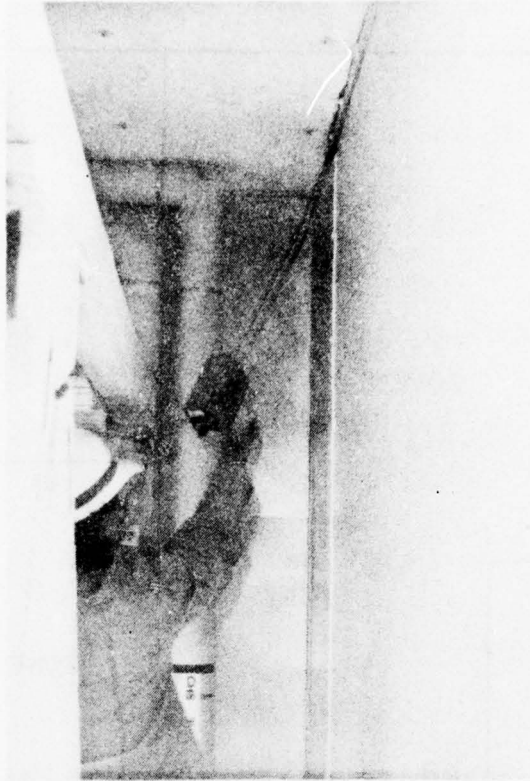
A Stoddard Model 900 Shielded Enclosure Leak Detection System consisting of a signal source and a separate hand-held receiver (Figure 3) was used for the sniffer tests in this investigation. Since a defect parallel to the direction of current flow might not be detected by a system with connections in only two corners, each shielded zone was provided with two sets of connections (Figure 4) to two sets of diagonally opposite corners. Thus, a leak undetected by one connection would be discovered by the other, and a leak could have different measured values for the two connections.

Figure 3. Shielded enclosure leak detection system ("sniffer") in use.

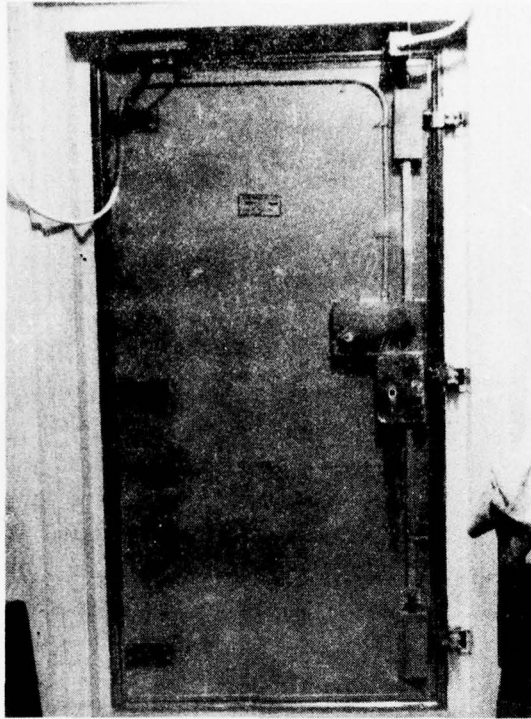
Figure 11. RF shielded door (201, exterior) with test points marked.

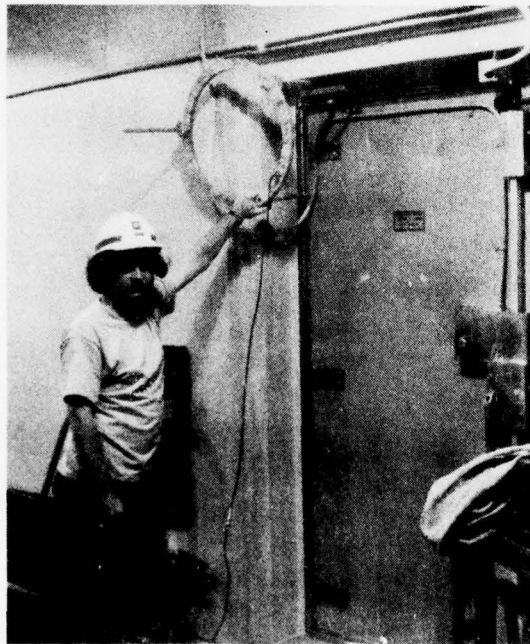
Figure 12. Radiating antenna (60 Hz to 10 kHz) positioned for test.

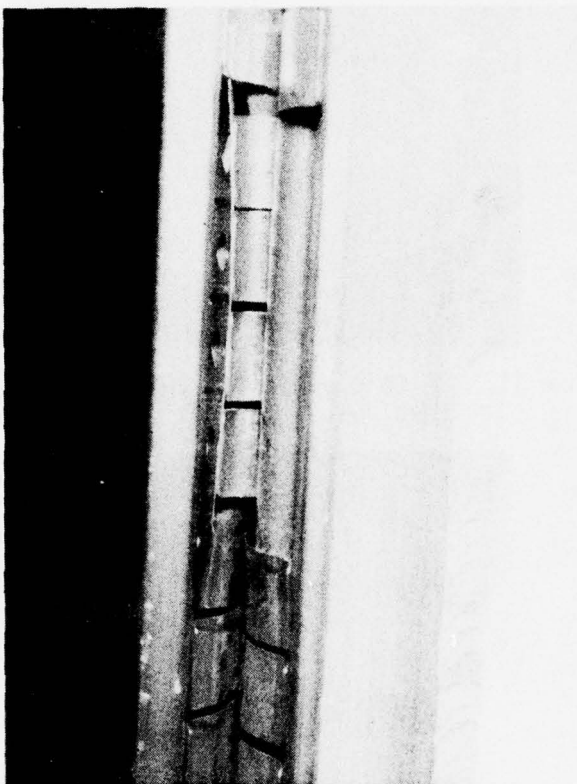
The fingerstock on door 111 (interior) had deteriorated considerably through normal use by 2 October 1976 (Figure 13). This door receives considerable use, and maintenance will be necessary for it to retain satisfactory shielding performance.

Figure 13. Damaged fingerstock, RF shielded door 111 (interior).
